Manhole Inspection Summary

Manhole # S17QQ1010MH

Insp Date: **6/27/07 8:33 AM**

Location Address: **SPRINGGARDEN DR**

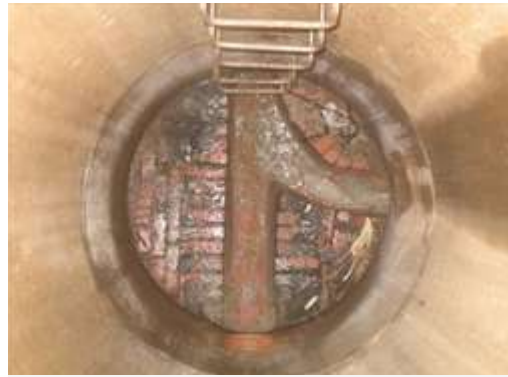
Top View

☒ **Debris** (not Condition related)

☒ **Evidence Of Surcharge**

Depth: **2.5** (ft.)

Evidence of surcharge - Bench debris.

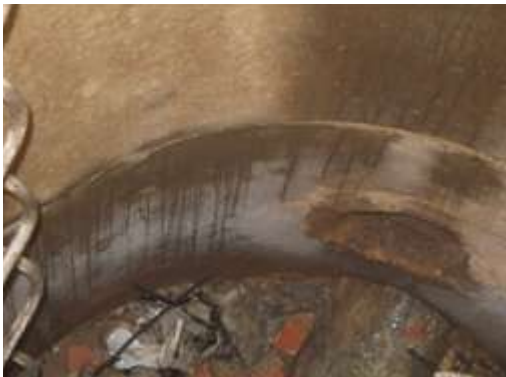
Defect

☒ **Joint**

Barrel infiltration.

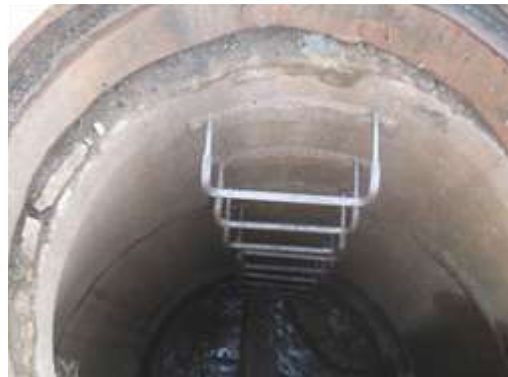
Defect

Offset: **3** (in.)

☒ **Leaks**

☒ **Deteriorated**

☒ **Joint**

Frame leaks. Frame offset. Adjustment deterioration and infiltration.

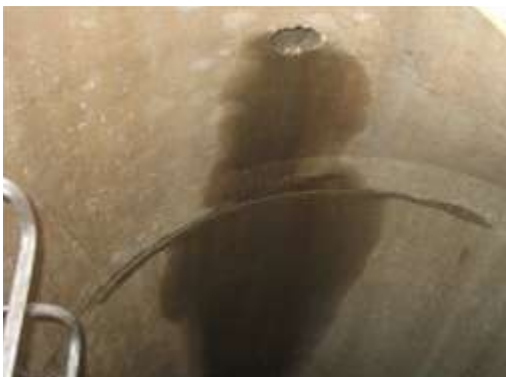
Defect

☒ **Wall**

Corbel infiltration. (Weep hole)

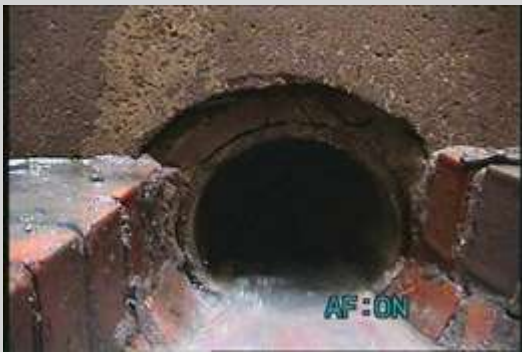
8 in. Circular Gravity Sewer Pipe Out @ 12 O'Clock

☒ **Deteriorated**

Channel deterioration.

Infiltration: **Evidence** Pipe Seal Cond: **Cracked**

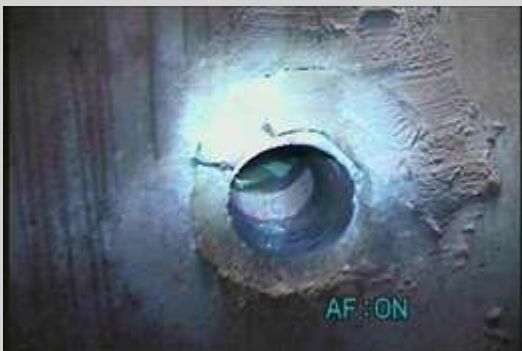
8 in. Circular Gravity Sewer Pipe In @ 3 O'Clock

Infiltration: **Evidence** Pipe Seal Cond: **Unknown**

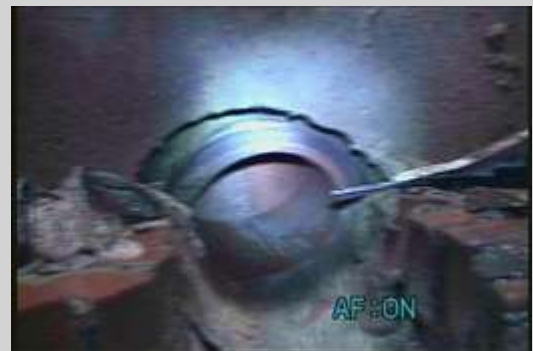
Drop In @ 3 O'Clock

Comments **Both the I3 and the I6 drop ext. pipe seals are not flush to the pipes.**

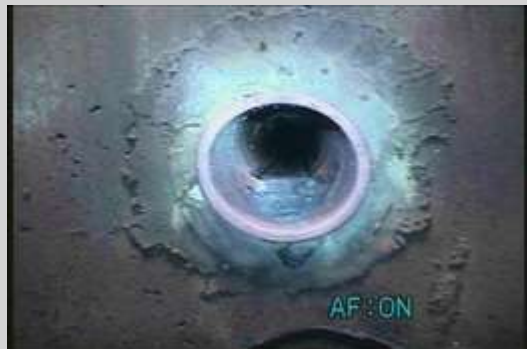
Pipe In @ 6 O'Clock

Infiltration: **Evidence**
